31 January 2011
Issue Number 0211

Fatality at French Paper Mill

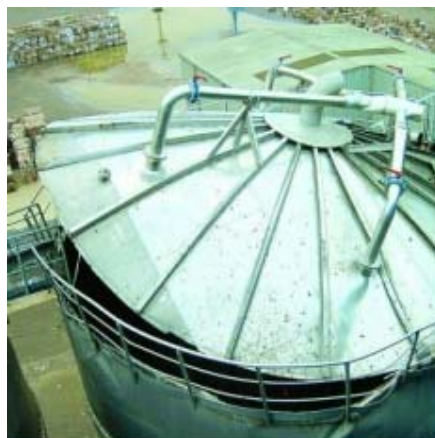
The top of the building affected was gutted and deformed by the blast. Under normal conditions pulp is stored before it is sent to the paper machine to form the sheet, and the damage has forced the plant to stop production until a technical solution to work without the tower is found.

The initial analysis is directed towards the heavy gas remaining on the surface of the pulp with a spark through the vent. **(The main hypothesis is explosive gas into tank due to anaerobic bacteria).** When one of the two boilermakers attached a pipe to the grinder, there was a loud explosion inside the tower and the roof was raised on one side. The worker who was on this side was thrown over the guardrail and fell 15 feet below.

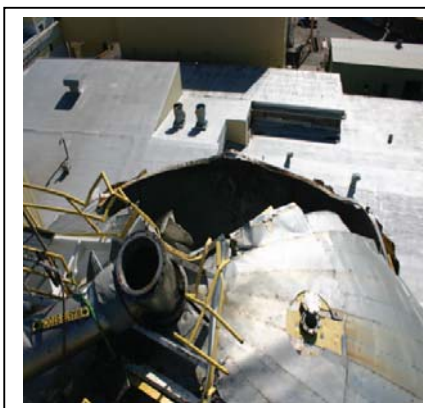
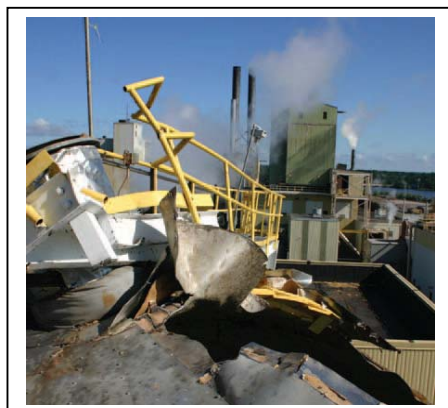
Contrary to the above, this is not the first time that an explosion of this nature has occurred in the paper industry. **On July 29, 2008**, three workers were killed in an explosion at the **Packaging Corporation of America** (PCA) fibreboard manufacturing facility while they were welding on a temporary metal clamp to stabilize a damaged flange connection. The flange was located on top of an 80-foot tall storage tank that contained recycled water and fibre waste.

Site personnel were unaware of the potential presence of flammable gas from the decomposition of the organic material in the tank, and combustible gas monitoring was not typically required or performed prior to starting work. At the time of the accident, three workers were on a catwalk above the tank; one began welding the flange into place when sparks from the welding ignited flammable vapours inside the tank. Analysis of the tank contents determined that anaerobic bacteria had multiplied inside the tank and water recycle system over time, feeding on organic waste material. The bacteria likely produced hydrogen, a highly flammable gas, which ignited during the welding work.

Source: CSB website - Views of the storage tank involved in the 2008 explosion at Packaging Corporation of America.

- **Use Alternatives** – Whenever possible, avoid hot work and consider alternative methods e.g. cold or hydraulic cutting
- **Identify the Hazards** – Prior to the initiation of hot work, perform a task related risk assessment that identifies the scope of the work, potential hazards, and methods of hazard control.

- **Monitor the Atmosphere** – Conduct effective gas monitoring in the work area using a properly calibrated combustible gas detector prior to and during hot work activities, even in areas where a flammable atmosphere is not anticipated.

- **Test the Area** – In work areas where flammable liquids and gases are stored or handled, drain and/or purge all equipment and piping before hot work is conducted. When welding on or in the vicinity of storage tanks and other containers, properly test and if necessary continuously monitor all surrounding tanks or adjacent spaces (not just the tank or container being worked on) for the presence of flammables and eliminate potential sources of flammables.

- **Use Written Permits** – Ensure that qualified personnel familiar with the specific site hazards review and authorize all hot work and issue permits specifically identifying the work to be conducted and the required precautions.
- **Train Thoroughly** – Train personnel on hot work policies/procedures, proper use and calibration of combustible gas detectors, safety equipment, and job specific hazards and controls in a language understood by the workforce
- **Supervise Contractors** – Provide safety supervision for outside contractors conducting hot work. Inform contractors about site-specific hazards including the presence of flammable materials.
